Job No. CB175119

This letter transmits two copies of our report of slope stability investigation, prepared for the All American Asphalt Quarry (SMP 95-1), located in the City of Corona, California.

**SLOPE STABILITY INVESTIGATION
AMENDED RECLAMATION OF ALL AMERICAN ASPHALT QUARRY
SMP 95-1
CITY OF CORONA, CALIFORNIA
PREPARED FOR
ENVIROMINE INC.
JOB NO. CB175119**

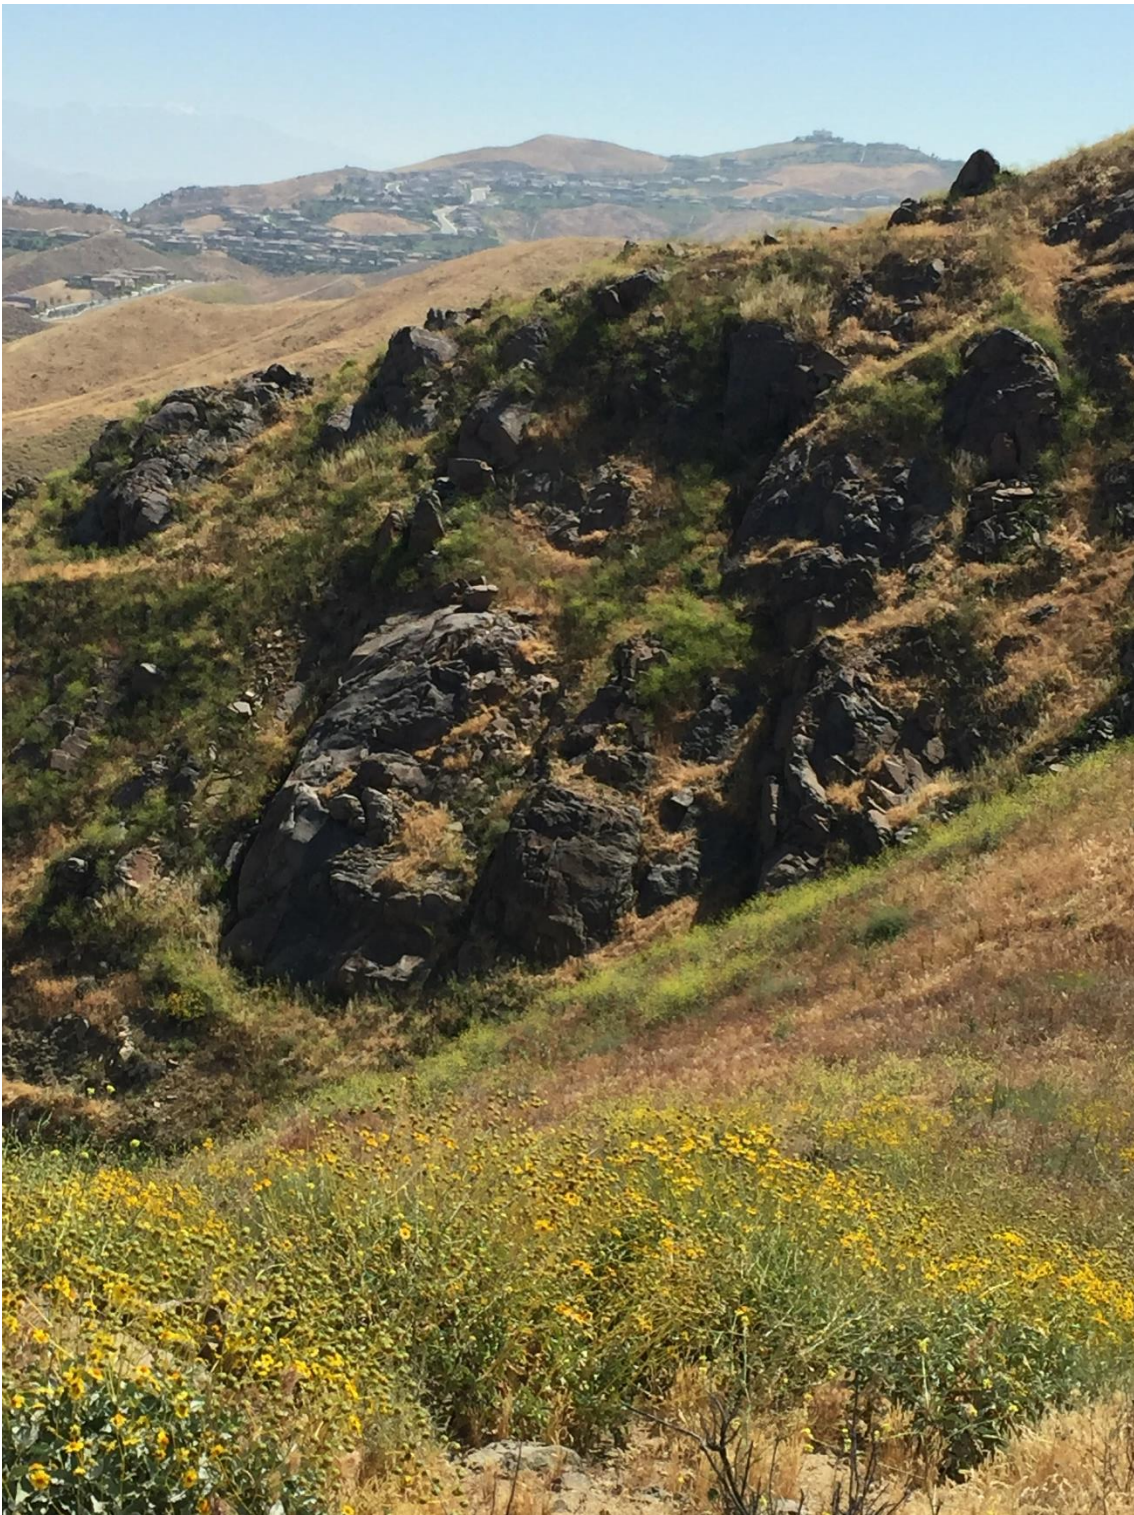
Photo 1: Native bedrock outcrop. View east.

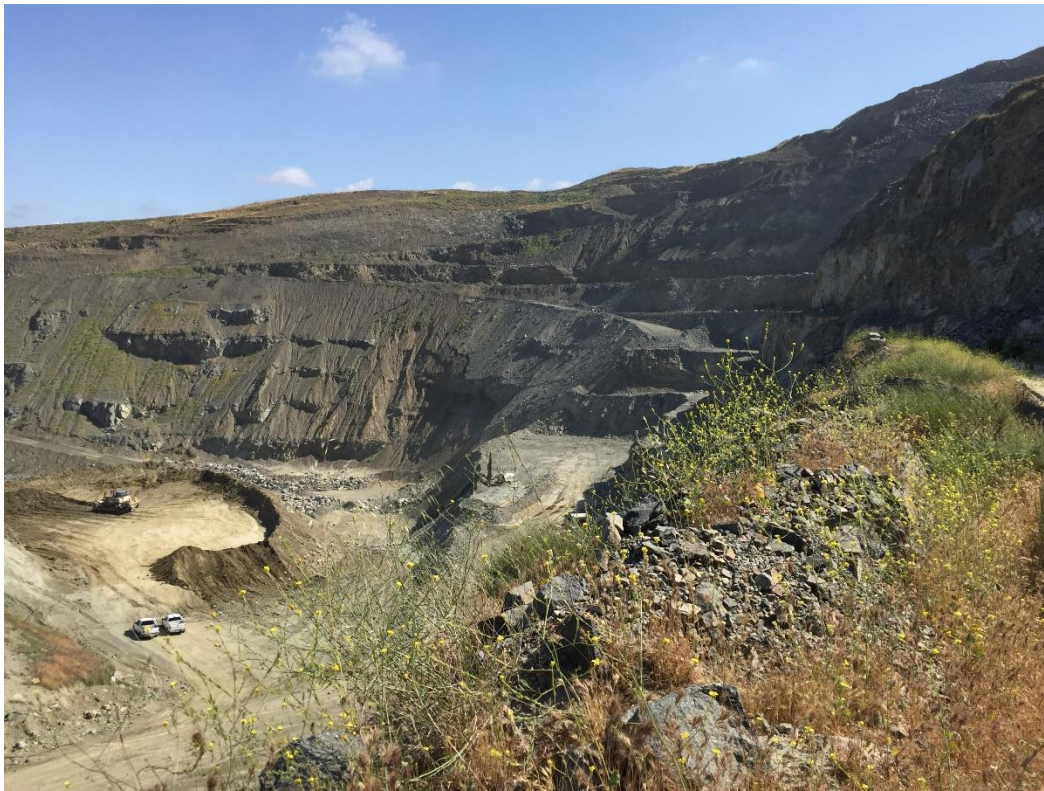
Photo 2: Mine slopes with slough over benches.

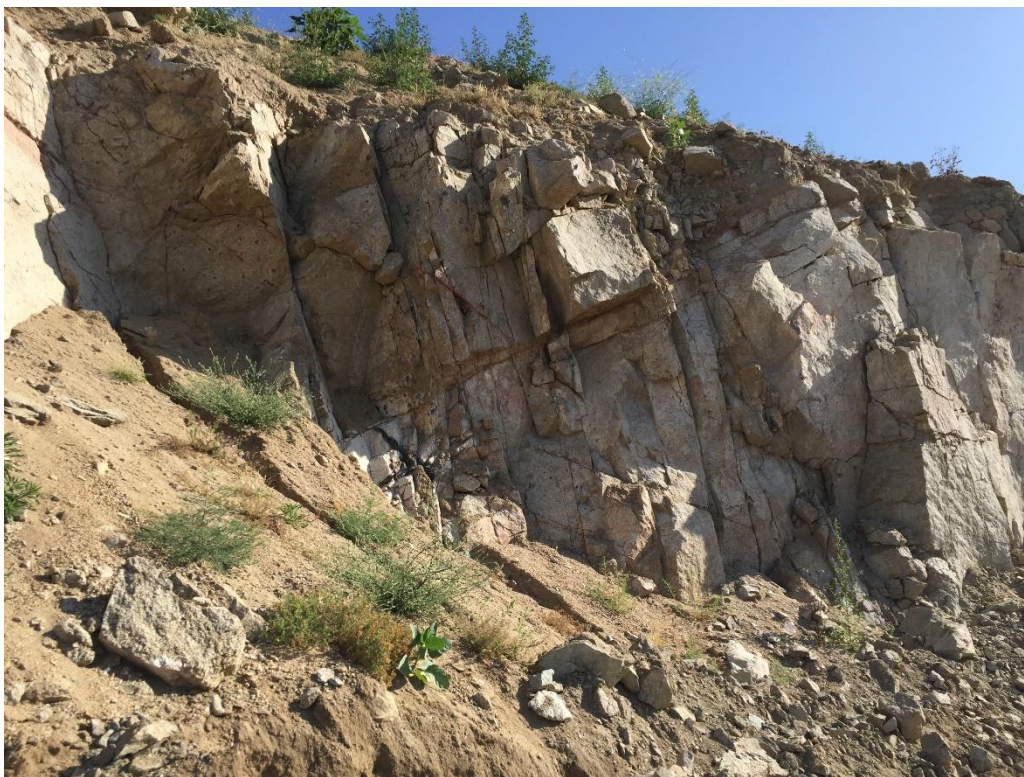
Photo 3: Granitics (Kcg) exposed in cut at north end of mine pit.

Medium- to coarse-grained tan granitics occur as an intrusive mass that trends roughly north-south across the western portion of the pit (photograph no. 3). As observed in mine exposures, these are locally in fault contact with unit Kvspi. Kcg weathers to a tan color, forms a friable residuum where highly weathered, and exhibits brownish staining on fracture surfaces. Fresh Kcg is hard to very hard based on examination of hand samples. Dark mineral enclaves occur locally where unit Kcg is in contact with Kvspi.

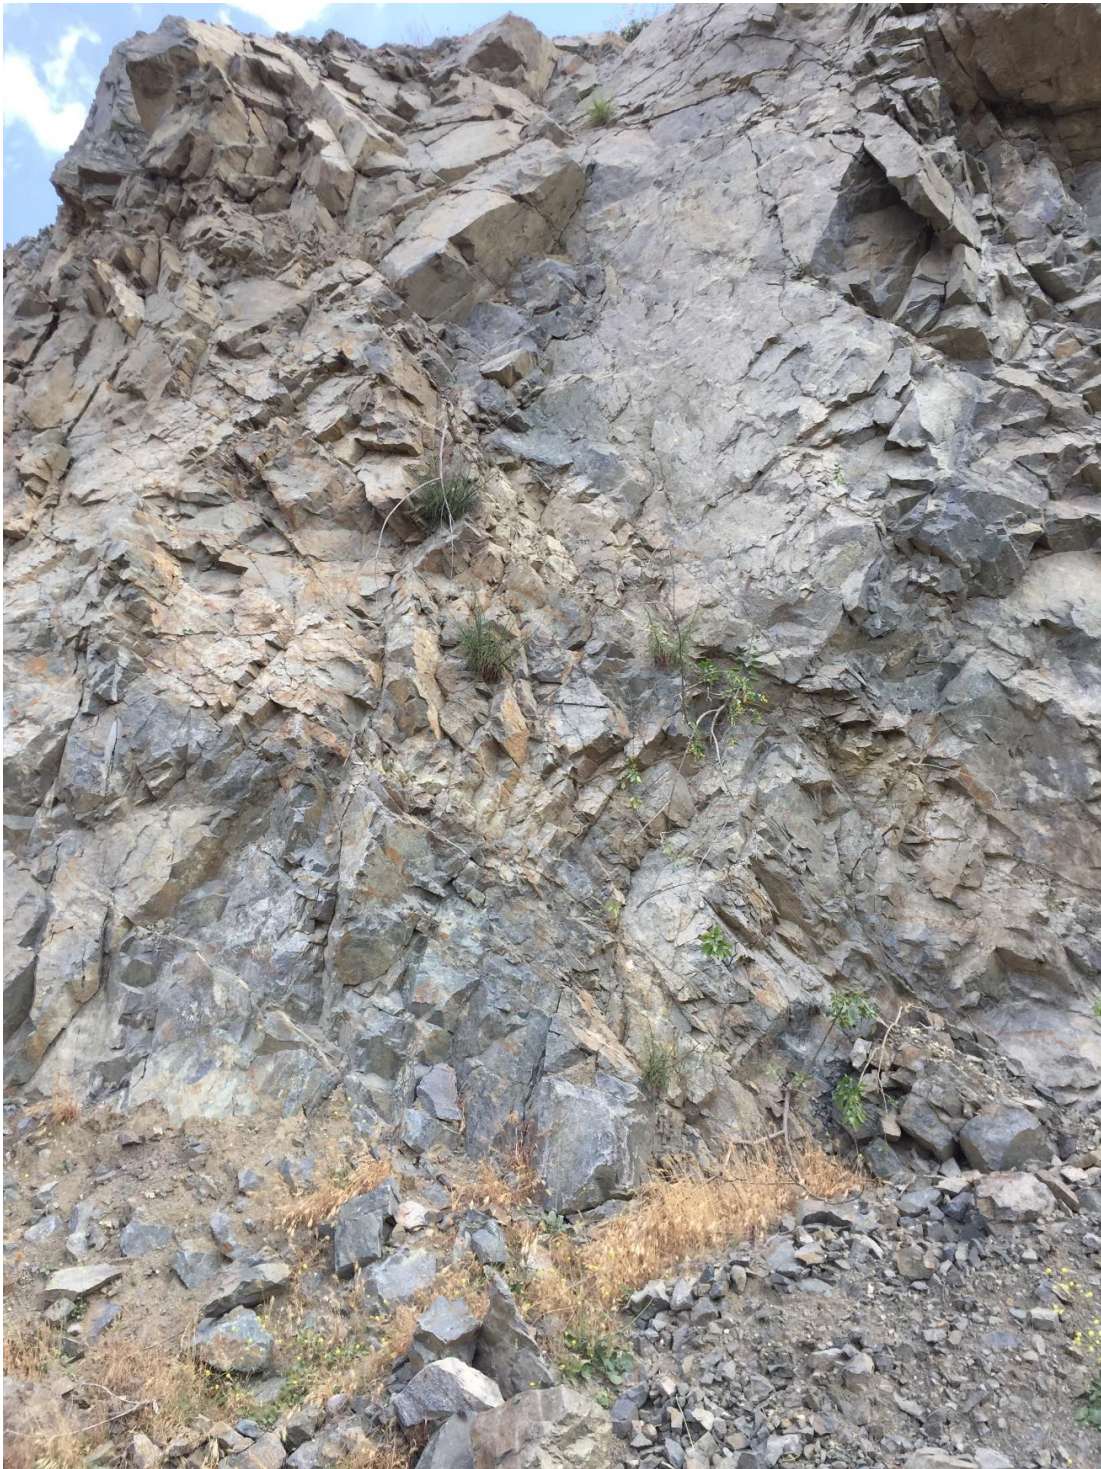
Photo 4: Intrusives associated with Santiago Volcanics (Kvspi).

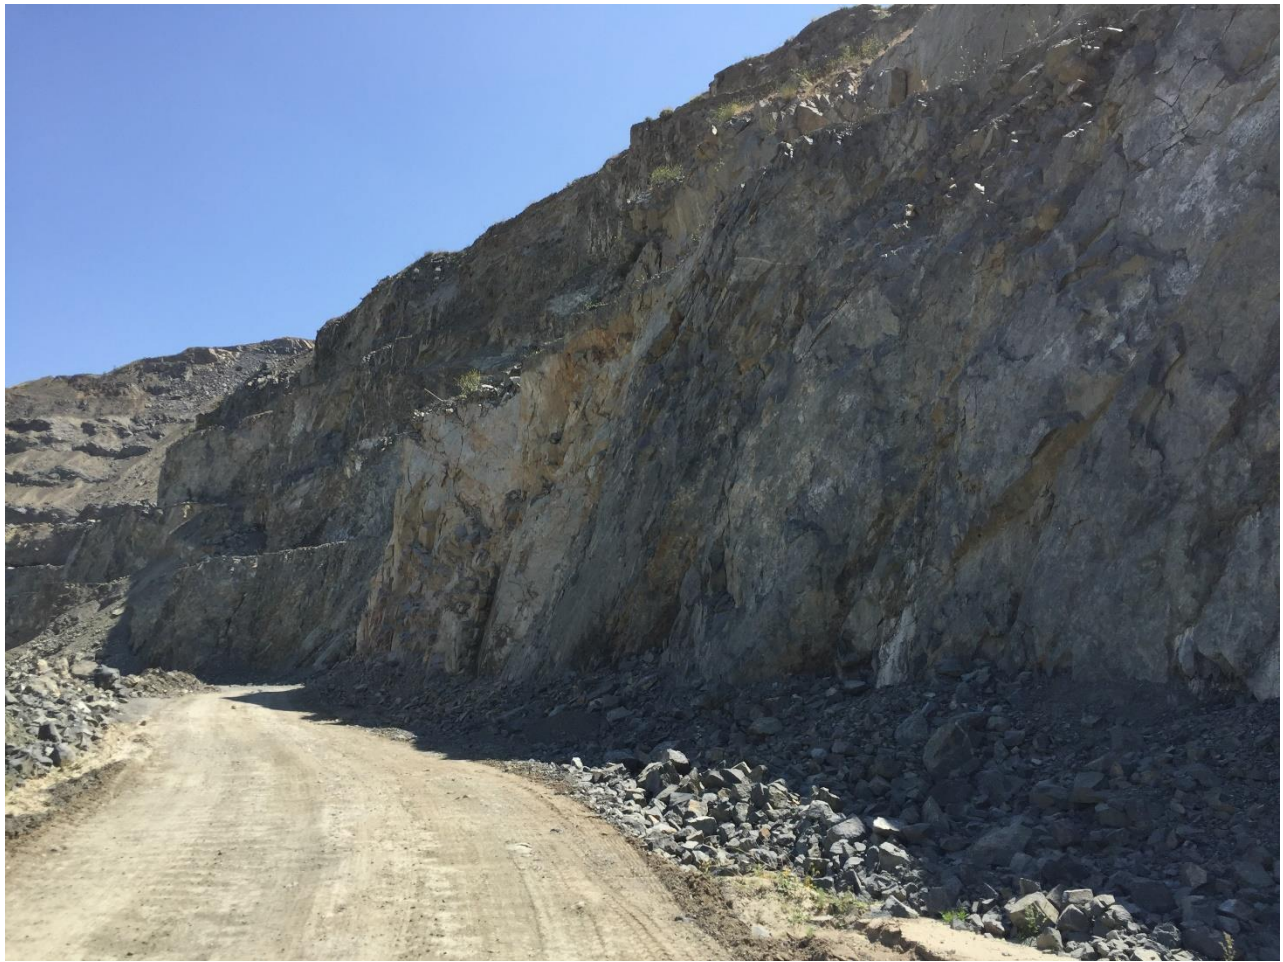
Photo 5: Typical joint controlled, blocky bench faces – south high wall.

The intrusive rock units of the mine resource are jointed and mildly fractured, forming blocky high wall cuts with a relatively regular pattern of joints, fractures, faults (photograph no. 5). Several inactive faults are exposed in the south high wall. These typically dip eastward at moderate angles and are neutral to north-facing slope faces (photograph no. 6). Some form a contact between the granitic and intrusive units (photograph no. 7). One west-dipping fault was observed. An inactive bedrock fault is mapped by Gray and others (2002) as forming and offsetting a contact along the northeast pit margin. The contact fault is not currently exposed as mapped by Gray and others; however, a smaller fault was observed near the Location 1. We interpret the smaller fault to be a conjugate of and related to the larger mapped fault. The potential for faults to influence slope geometry is addressed in the "Kinematic Evaluation" section of this report.

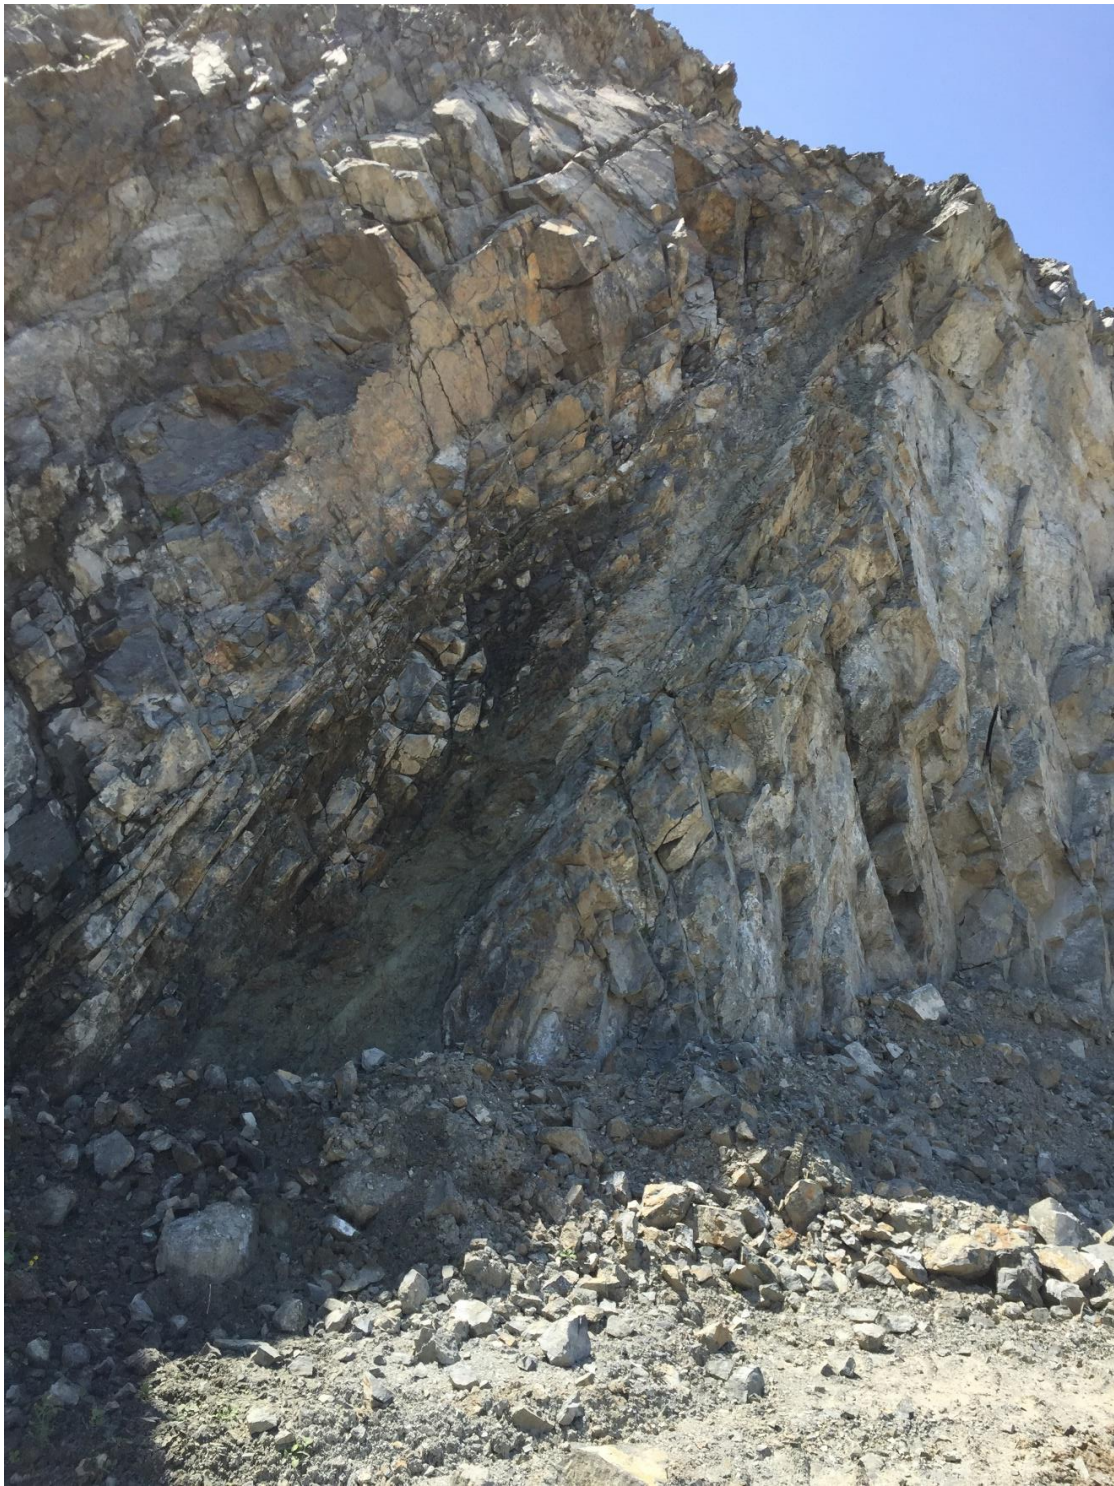
Photo 6: East-dipping fault with gouge and zones of seepage – south high wall.

We observed slight seepage and enhanced plant growth along bedrock faults in the southern portion of the site. An adjacent mine operator reportedly releases surface flow to a ravine adjacent to the south access road above the south high wall. The seepage occurs in an unconfined state as a result of overland flow and local infiltration. Evidence of a groundwater table was not observed in the pit, and no standing water was present. The western portion of the site, near Temescal Wash, is within an area of "low" liquefaction susceptibility according to the Riverside County Integrated Project (2013). This area of the site is outside of quarry boundary and is not anticipated to be affected by mining activities.

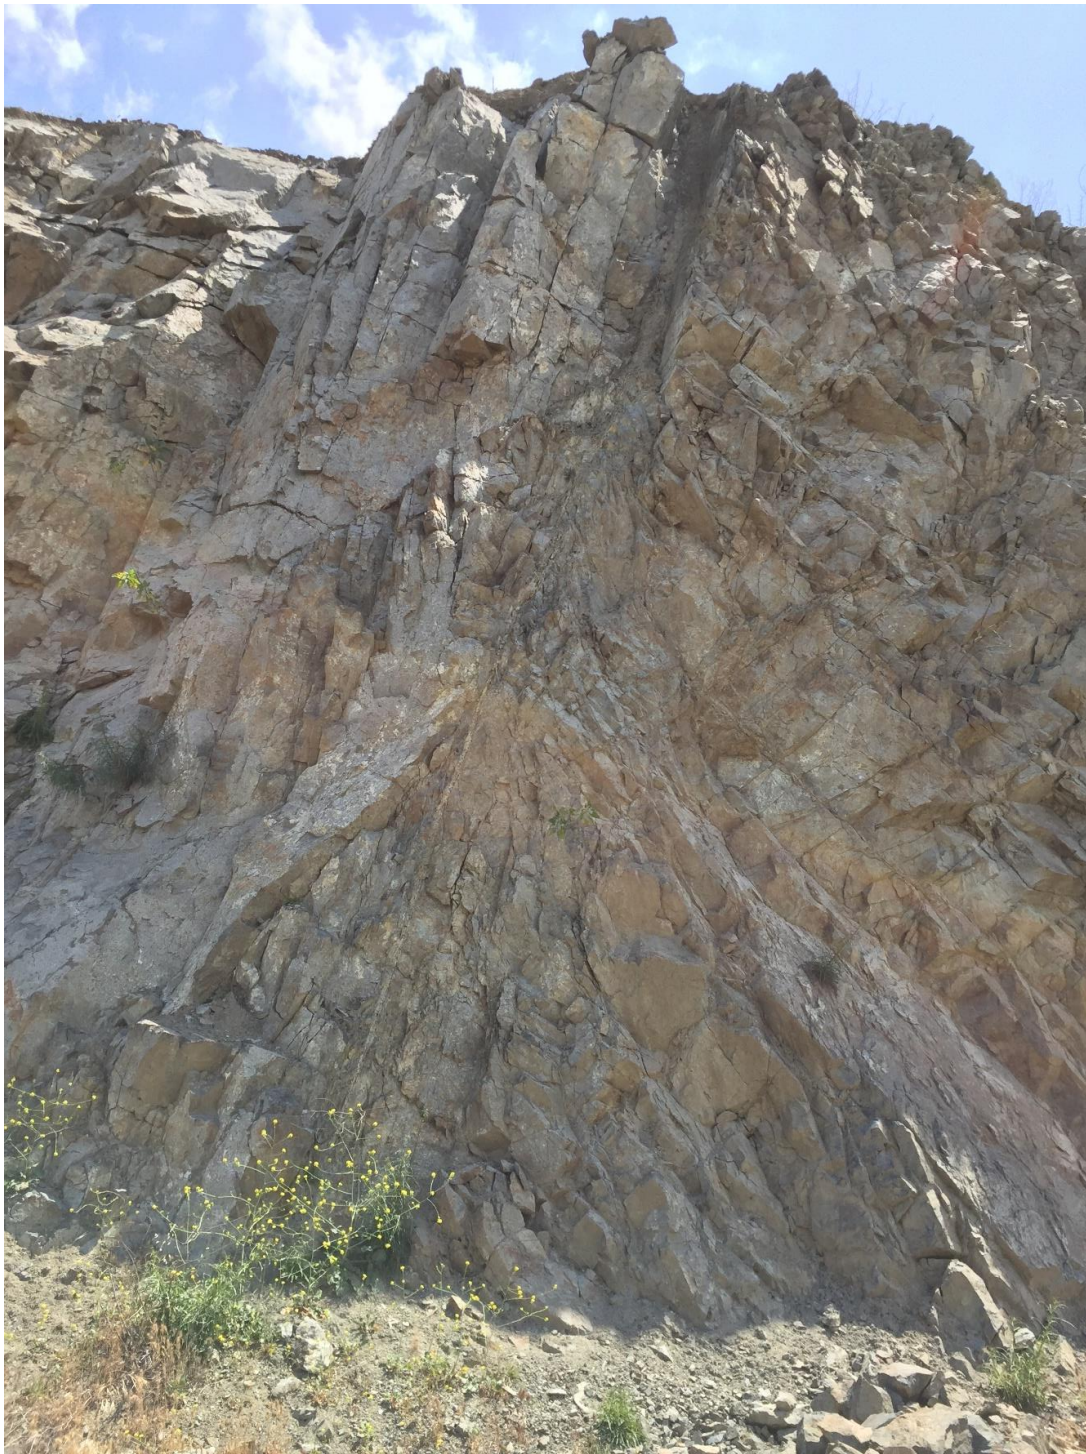
Photo 7: Steeply-dipping fault contact between porphyritic phase of Kvspi (left) and Kcg (right).

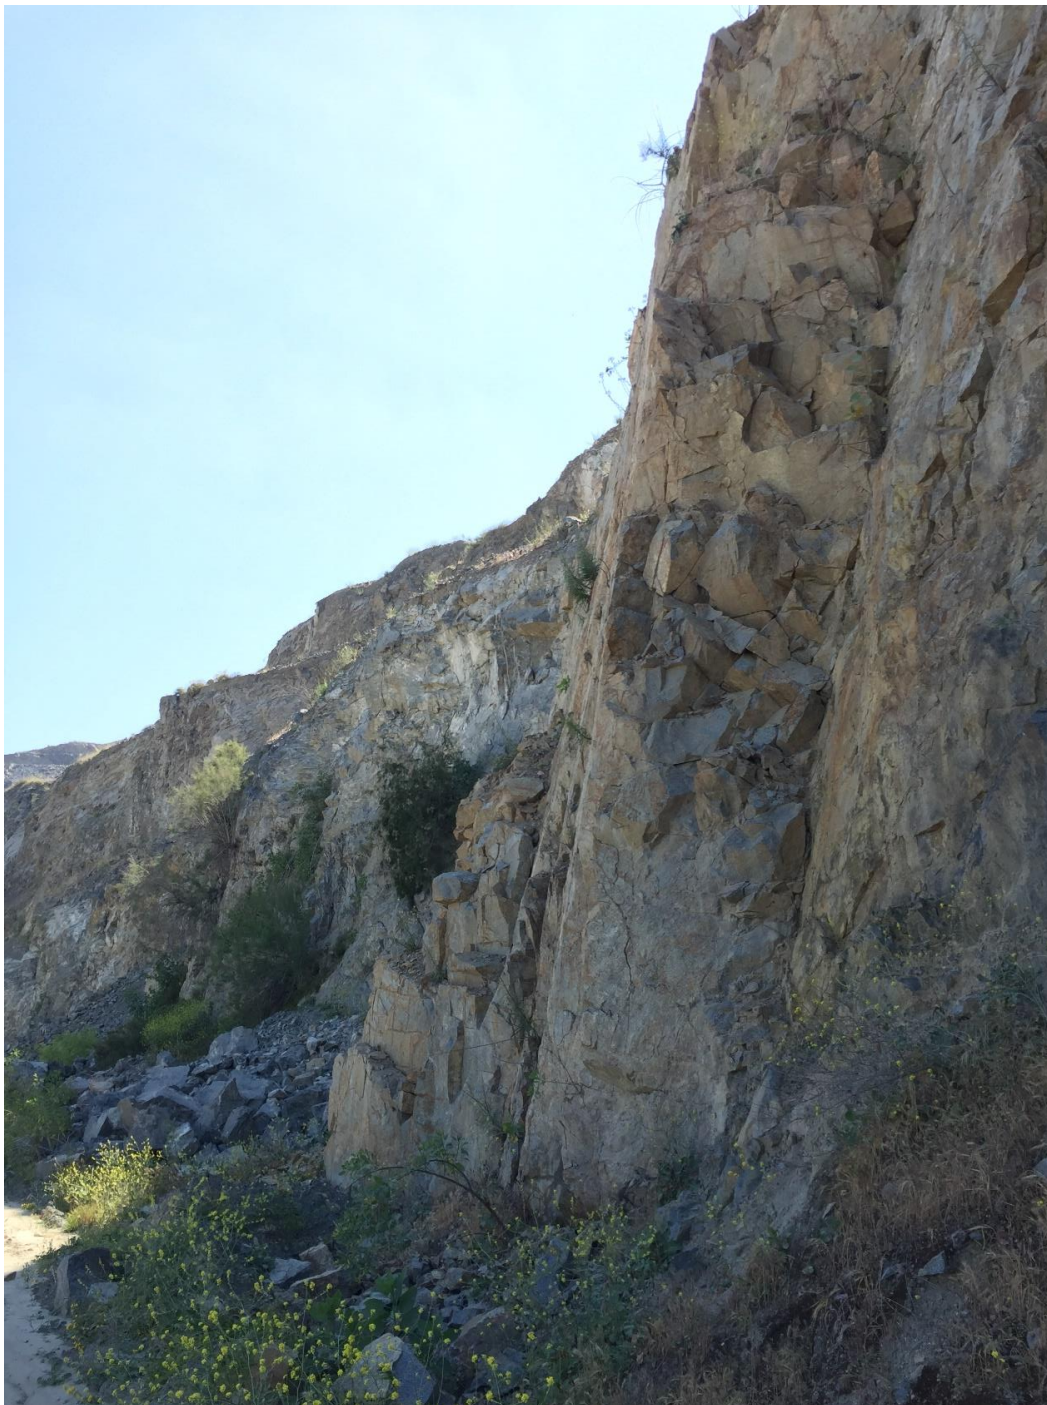
Photo 8: Steeply-dipping, joint-controlled bench faces – south high wall.

The majority of more-continuous bedrock discontinuities consist of steeply-dipping joints that dip more steeply than or control the bench face angle (photograph no. 8). At the bench/face scale, discontinuities are primarily block-forming, random fractures developed as a result of blast fracture. Unit contacts consist of sharp intrusive and fault contacts between the Kcg and Kvspi units. Based on these observations and the results of our investigation, deep-seated landsliding is not anticipated in the proposed slopes. Analyses of the proposed reclamation slopes are presented in the following section as kinematic analysis and slope stability calculations.

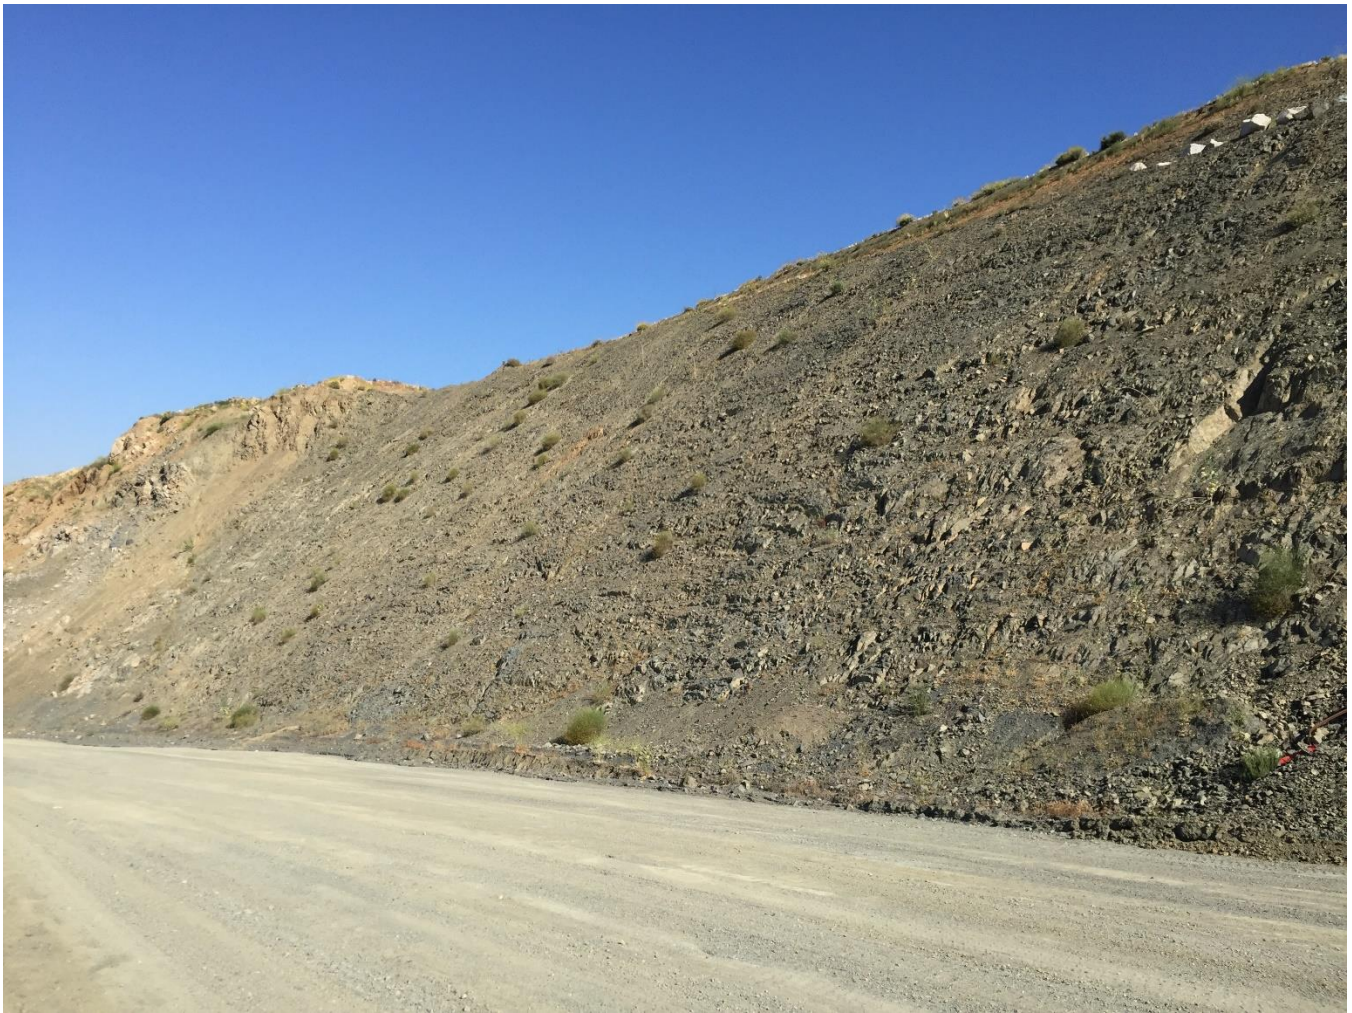
Photo 9: Southwest-facing slope along northeast pit margin. View toward Location 1.
